TRIP REPORT

TO: JFO File: Chuck Hayes / SOP-12017

Subject: 7-25-16 Site Visit in response to spill at Chuck Hayes Facility

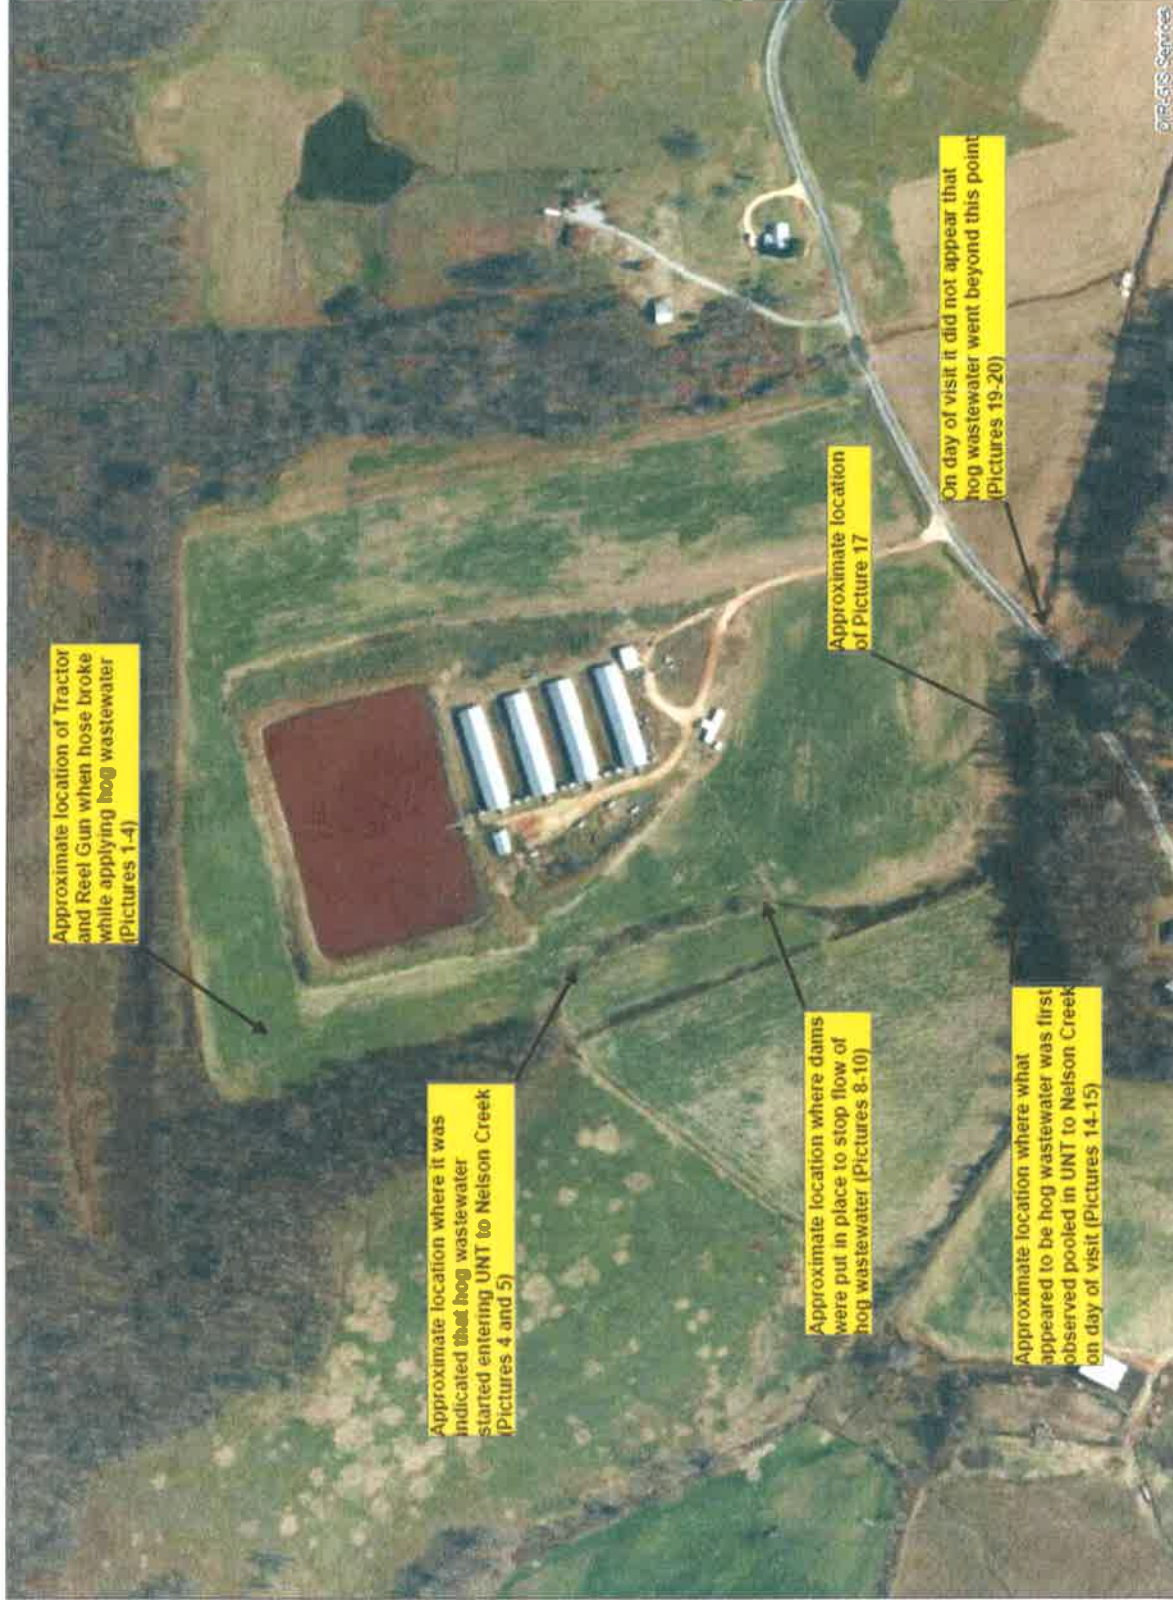
Figure 1

Mr. Barron showed me the location of the dams he made in the drainage in an effort to stop the wastewater from continuing to flow down the drainage ditch (Pictures 8-10; Figure 1). Mr. Barron made the dams by pushing dirt in the drainage ditch. Mr. Barron made a second dam after they seen that some wastewater was trickling through the first dam. I did not observe pooled wastewater in the drainage ditch up-gradient or immediately down-gradient of the area where the dams were put in place (Pictures 7 and 11). Mr. Barron indicated he was using the bucket of a skid steer to dip wastewater out of the drainage ditch up-gradient of the dams he had made and then was dumping it in an area of the field away from the drainage ditch, which had not received wastewater (Picture 6). I did observe pooled wastewater in the drainage ditch further south (down-gradient) toward Jim Merrell Road. The first pooled wastewater I observed was in a bend of the drainage ditch (Figure 1; Pictures 14-15). There was quite a bit of pooled wastewater between the bend where I first observed the pooled wastewater and Jim Merrell Road (Figure 1; Pictures 14-18). Mr. Barron indicated that they pumped most of the wastewater out of the drainage ditch on Friday July 22, 2016 but they received approximately 0.2 inches of rain on Saturday July 23, 2016. Mr. Barron didn't know if that rainfall event might have washed some wastewater down the drainage ditch or if there was some wastewater that worked its way on down the drainage ditch after they stopped pumping out the drainage ditch on the night of July 22, 2016. Mr. Hayes indicated according to the pump truck drivers approximately 20,000 gallons of wastewater was pumped out of the drainage ditch on Friday July 22, 2016.

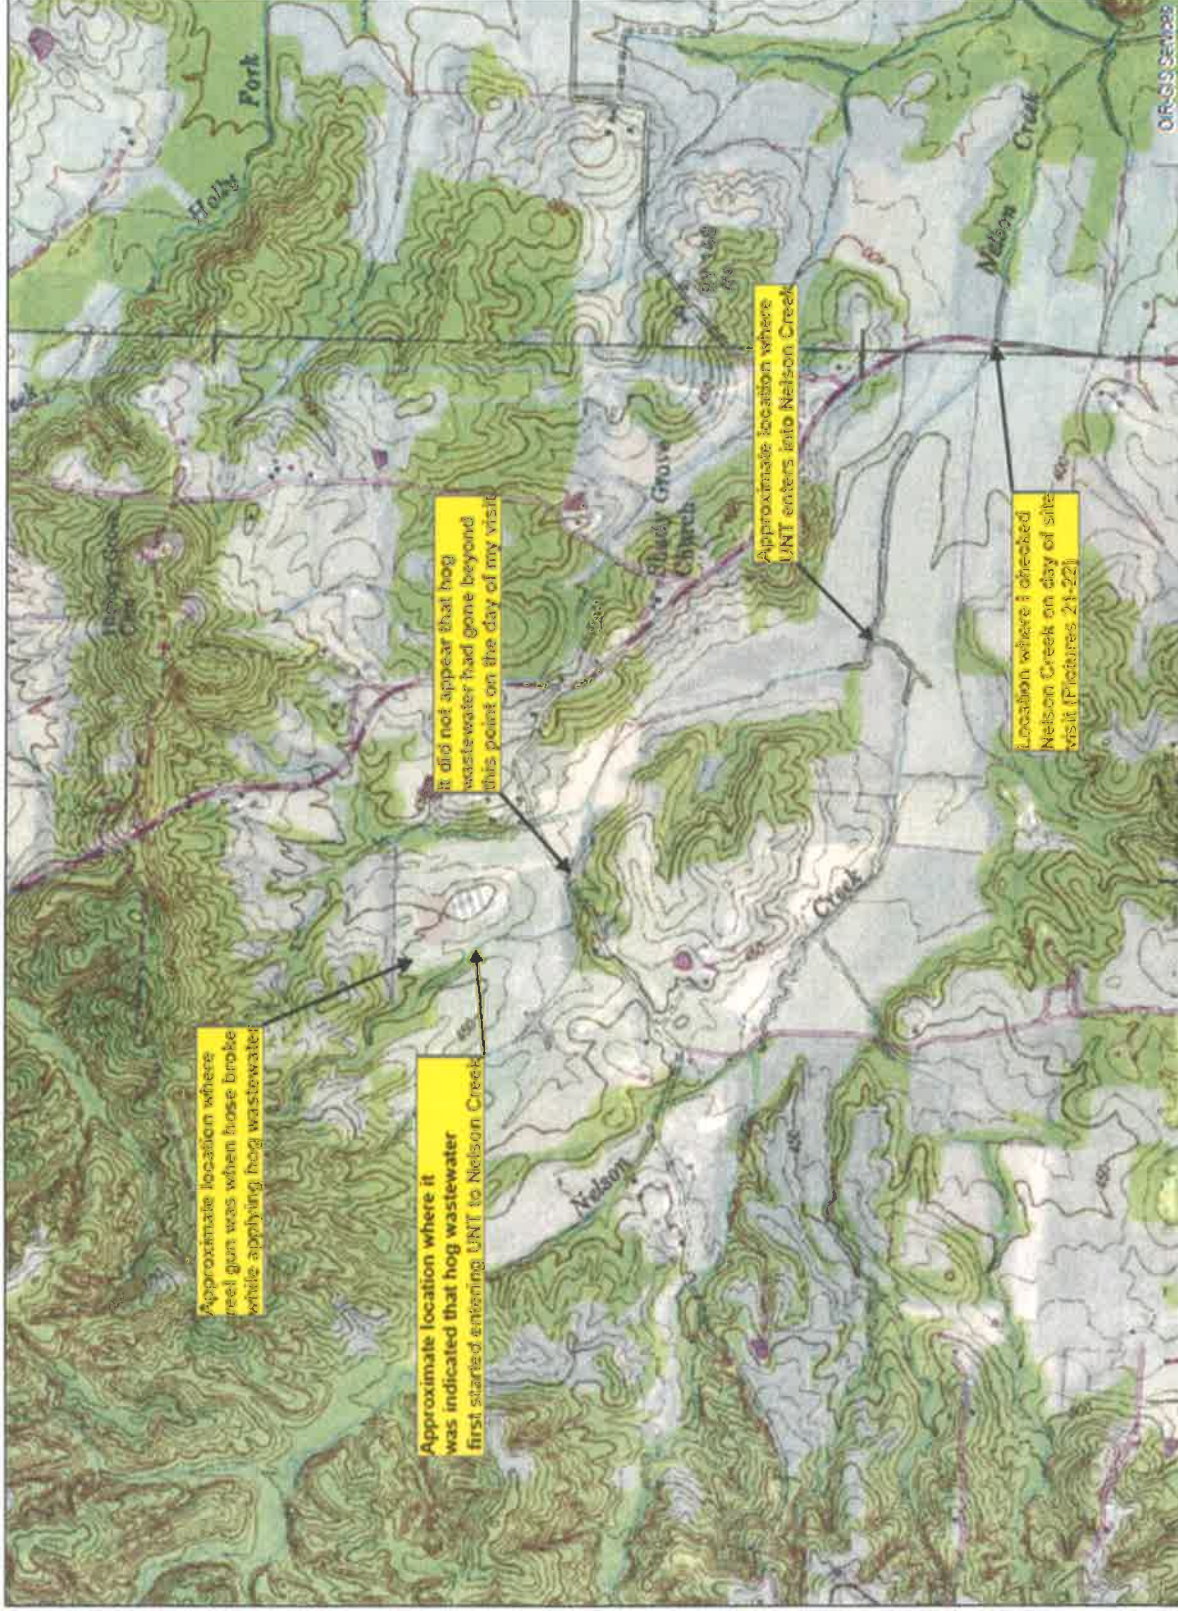
Figure 2

We then walked across Jim Merrell Road and I observed what appeared to be hog wastewater pooled in the drainage ditch on the south side of Jim Merrell Road. Based on the coloration of the water observed in the drainage ditch, it did not appear that the hog wastewater made it passed some rocks that were piled up in the drainage ditch (Pictures 19 and 20). From the point where the hog wastewater entered the drainage ditch to the point where it appears to have stopped on the south side of Jim Merrell Road is approximately 0.3 miles (Figure 2). From the point where the hog wastewater appeared to stop to the confluence of Nelson Creek is approximately 0.8 miles (Figure 2).

After leaving the facility I stopped on Shady Grove Road where Nelson Creek runs underneath it. I did not observe anything that appeared to be hog wastewater at this location (Pictures 21-22; Figure 2).
